WINDOW REPORT

Agulhas lighthouse ground floor front windows
W1 to W8

John Rennie
 Rennie Scurr Adendorff Architects
 1301/WindowReport/Jr
 26 May 2013

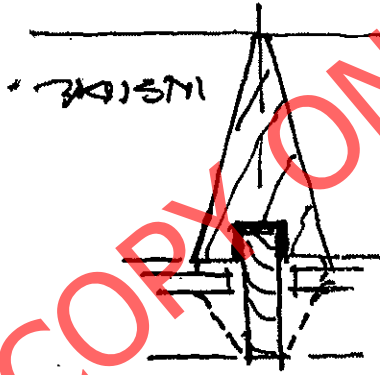
1:1 SKETCH

AGENTS VERAMATH WINDOWS : -
 THE CARPENTERS ASSEMBLING THE
 NEW VERAMATH BALUSTRADE
 SUGGESTED AN ADDED APPROACH
 TO THE RE-NOSING OF THE SLENDER
 GLAZING BARS - WORTH TRYING OUT.
 IDEA TO ROUT OUT AN ACCURATE
 NOST GROOVE TO FACILITATE
 CENTERING & GUIDING THE NEW
 NOSSES : -

See enlarged glazing bar detail overlaid showing striking the putty slightly back to allow crucial paint sealing to the glass face after the putty has cured and is firm.

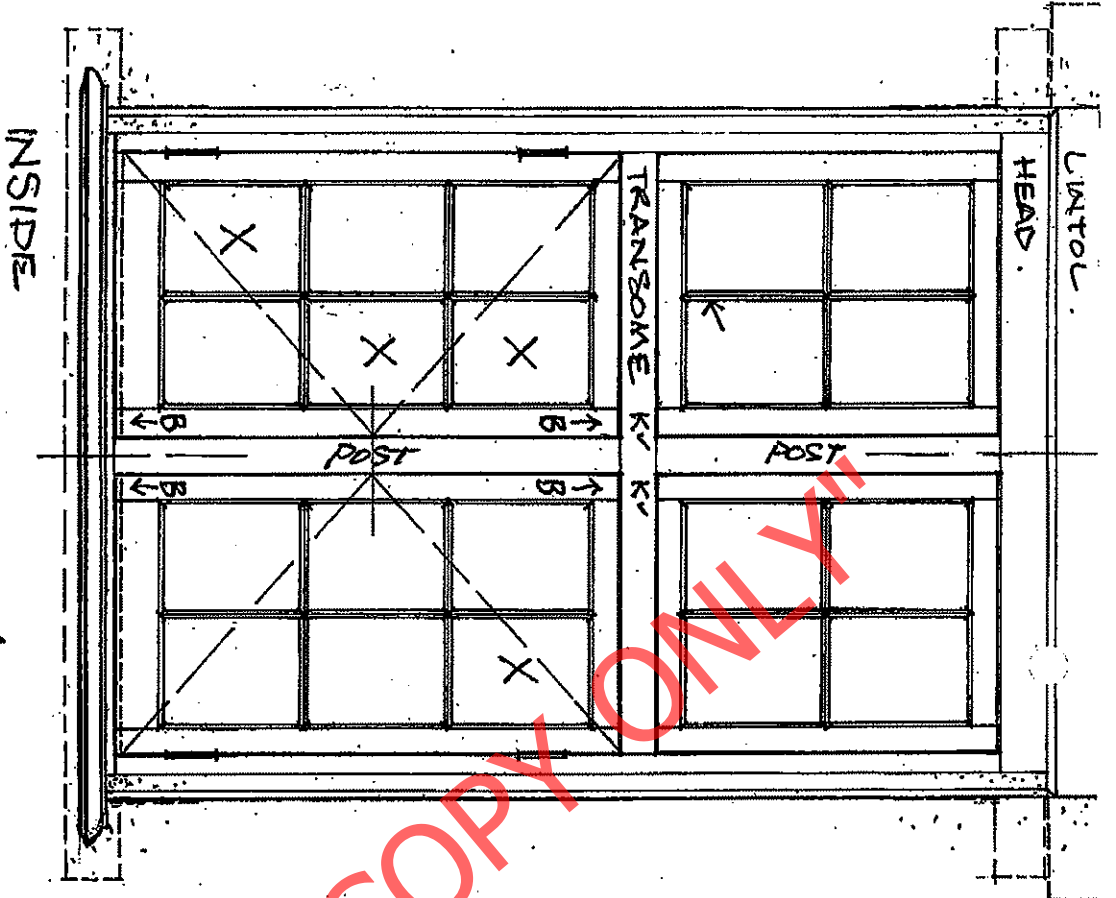
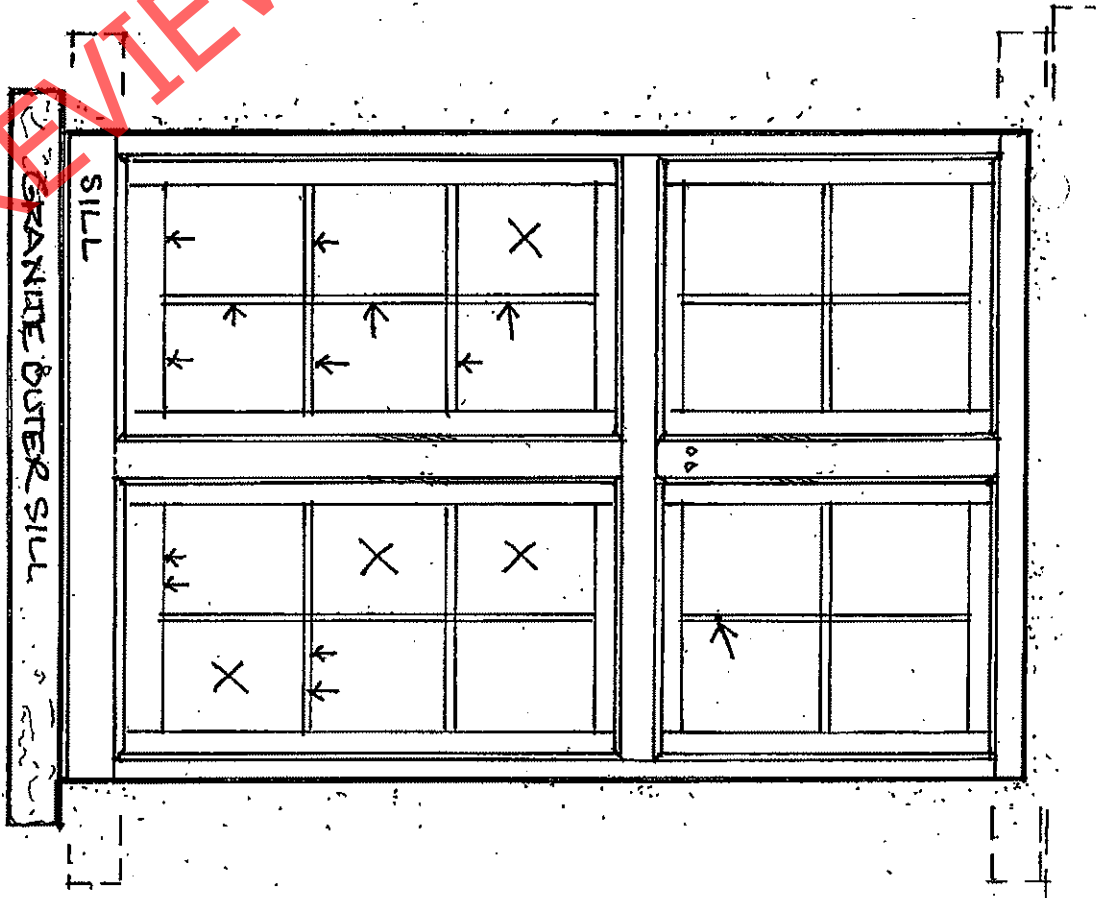
26/5/13
 1/8
 W1

- During the last 20 years deterioration has accelerated with exposure to the elements.
- Windows W1 and W2 (in the previous museum side were also hardboard-covered inside to block out light). Ingress during this time, 'out of sight, out of mind' has started to soften the casement bottom rails here at W1, W2 noticeably but not too seriously.

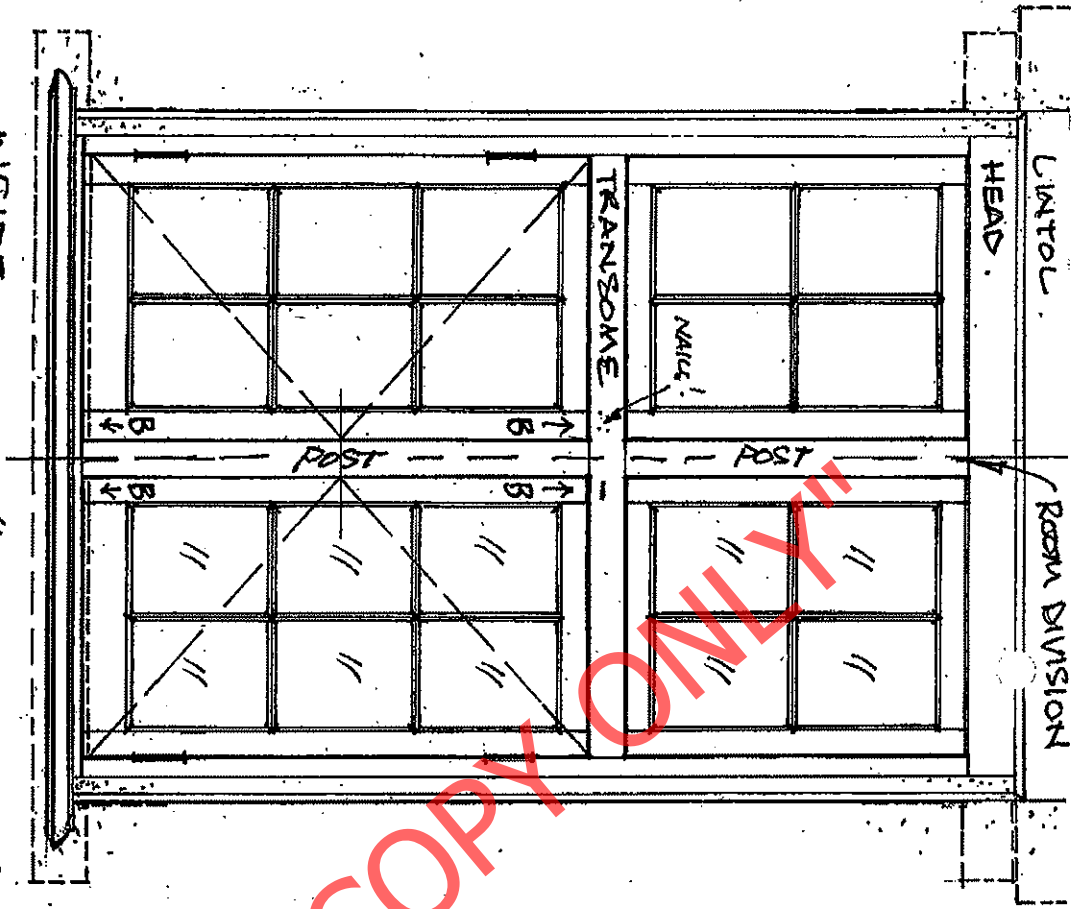
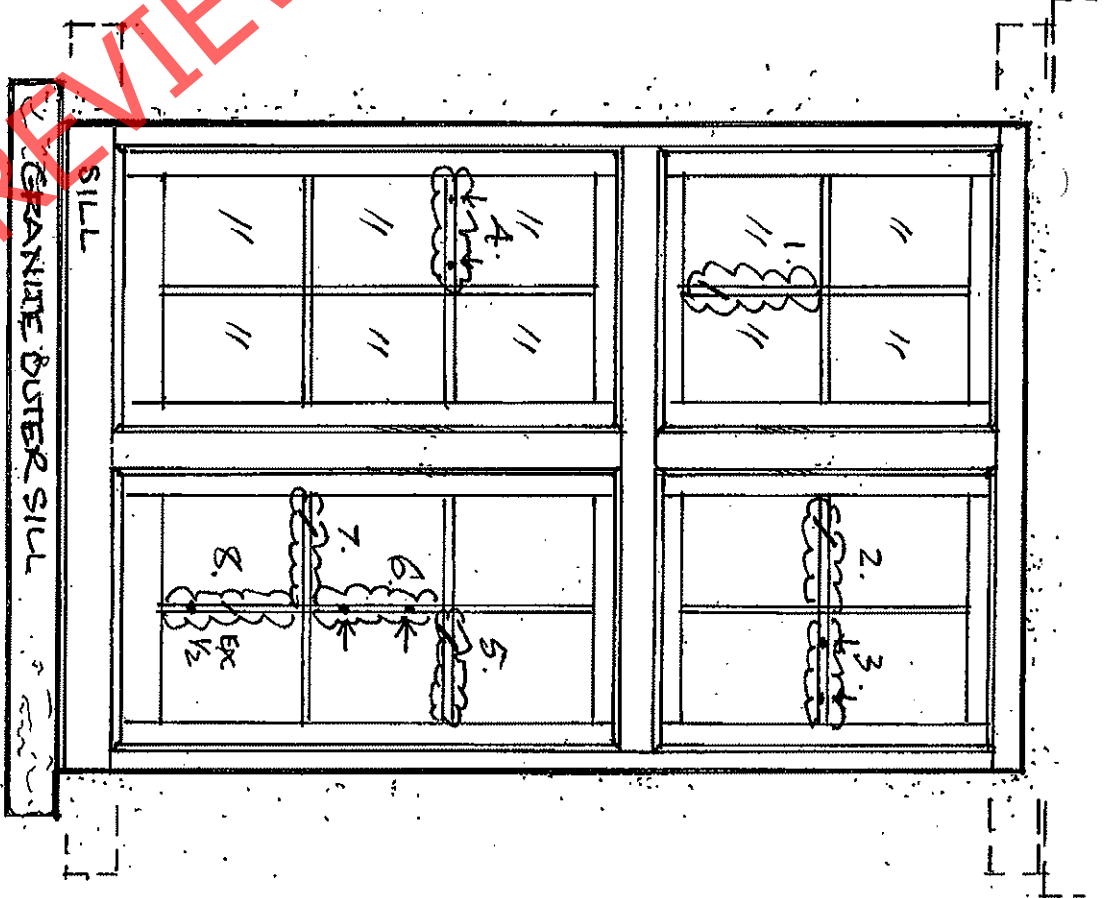
3/8 W3

OUTSIDE 8 NOSSES

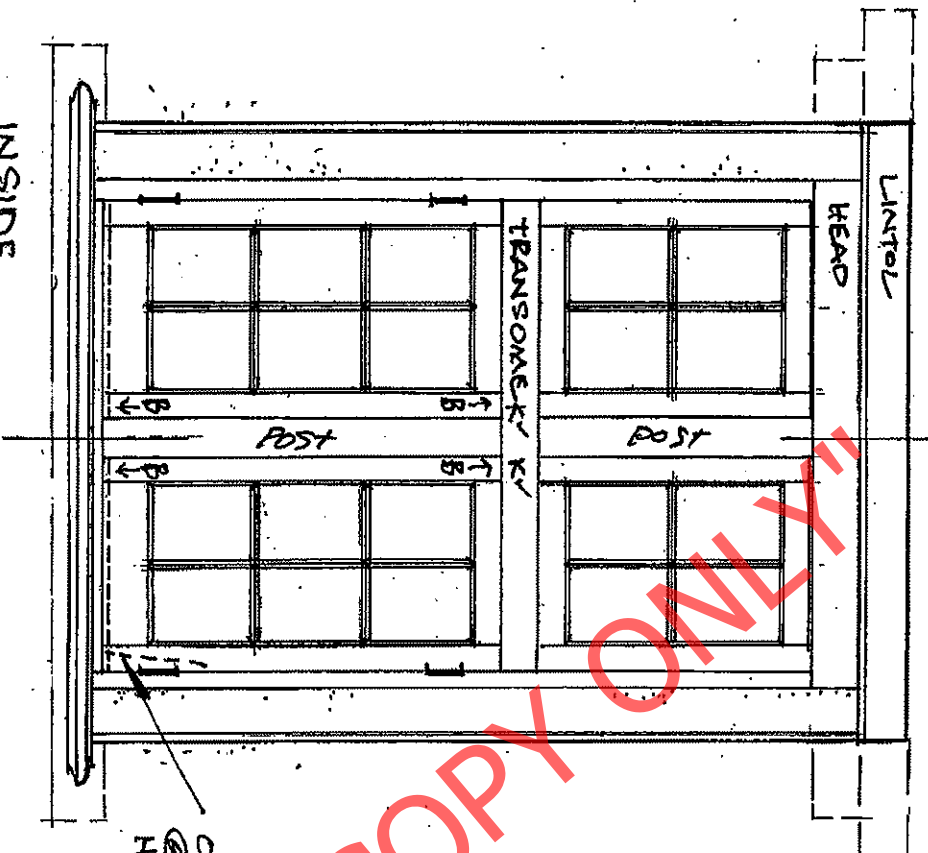
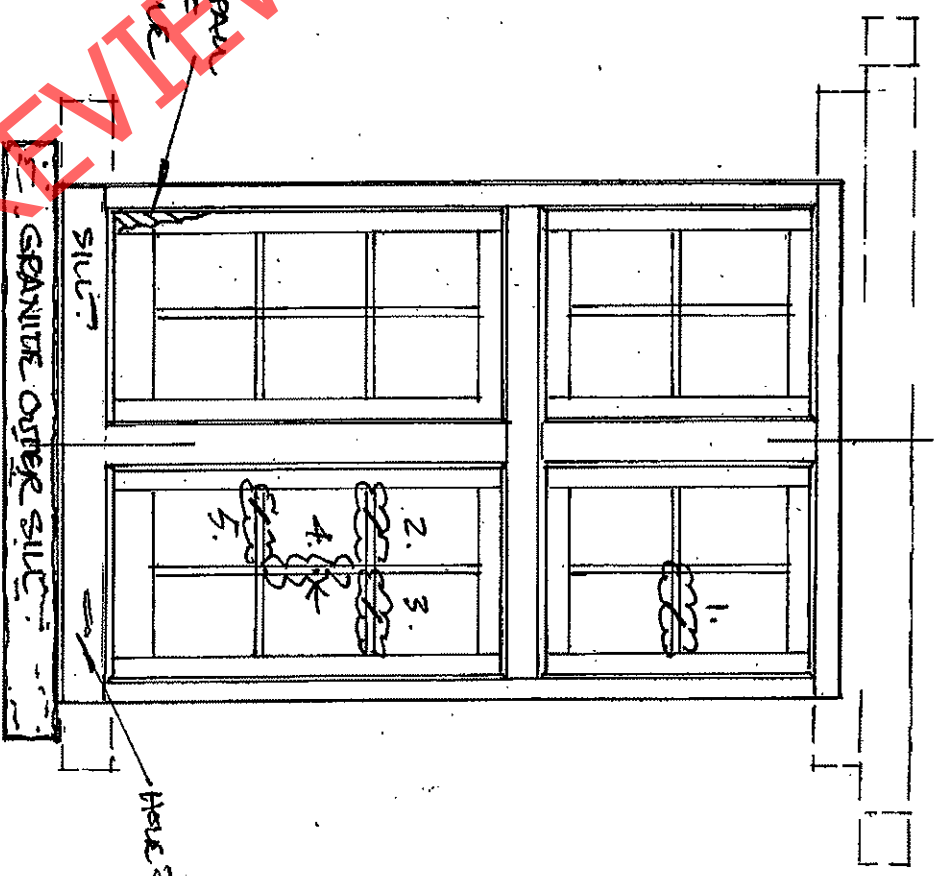
26/5/13.
 4/8
 W4

OUTSIDE. 5 NOSSES.

- outside:**
- W4 outside left casement: plane off angled spall at hinge-stile bottom heel ± 300 long x 45 thick.
- Balcotan 100 glue on replacement angled teak and plane off flush to reinstaate face and edge.

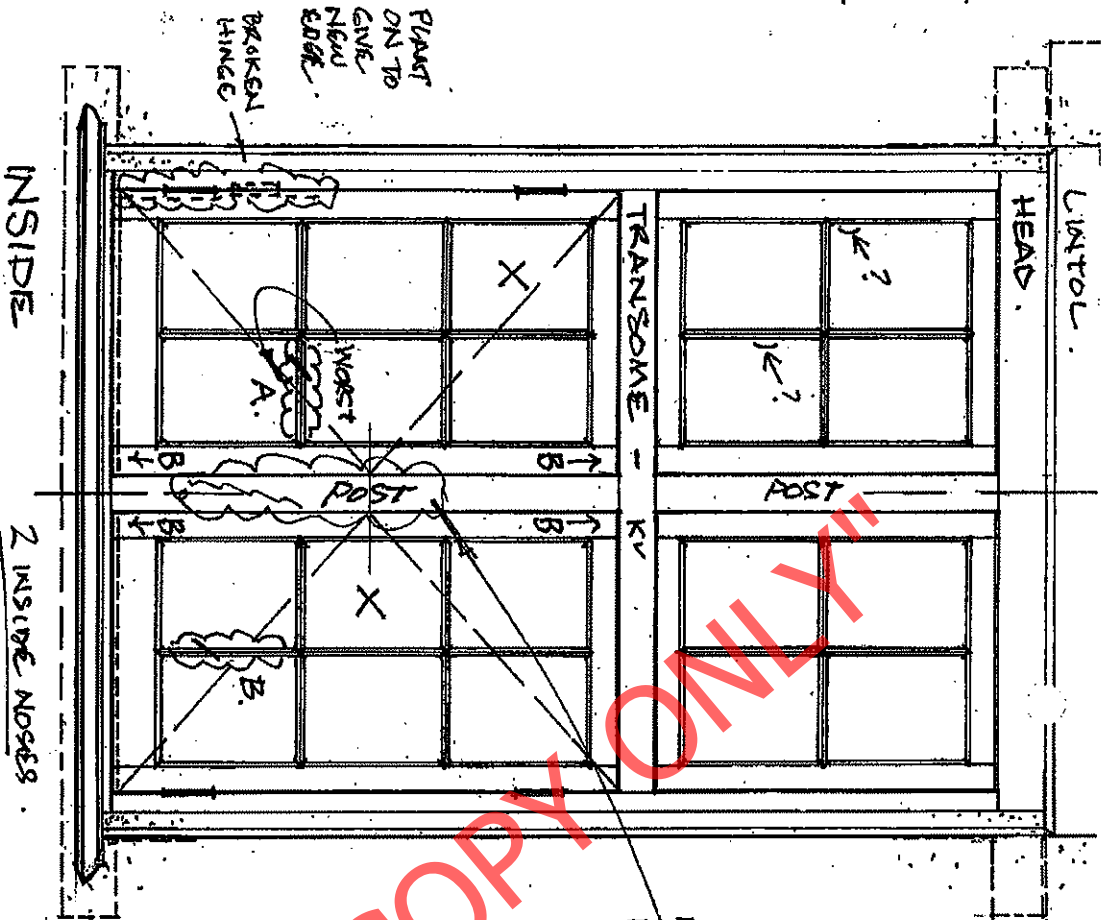
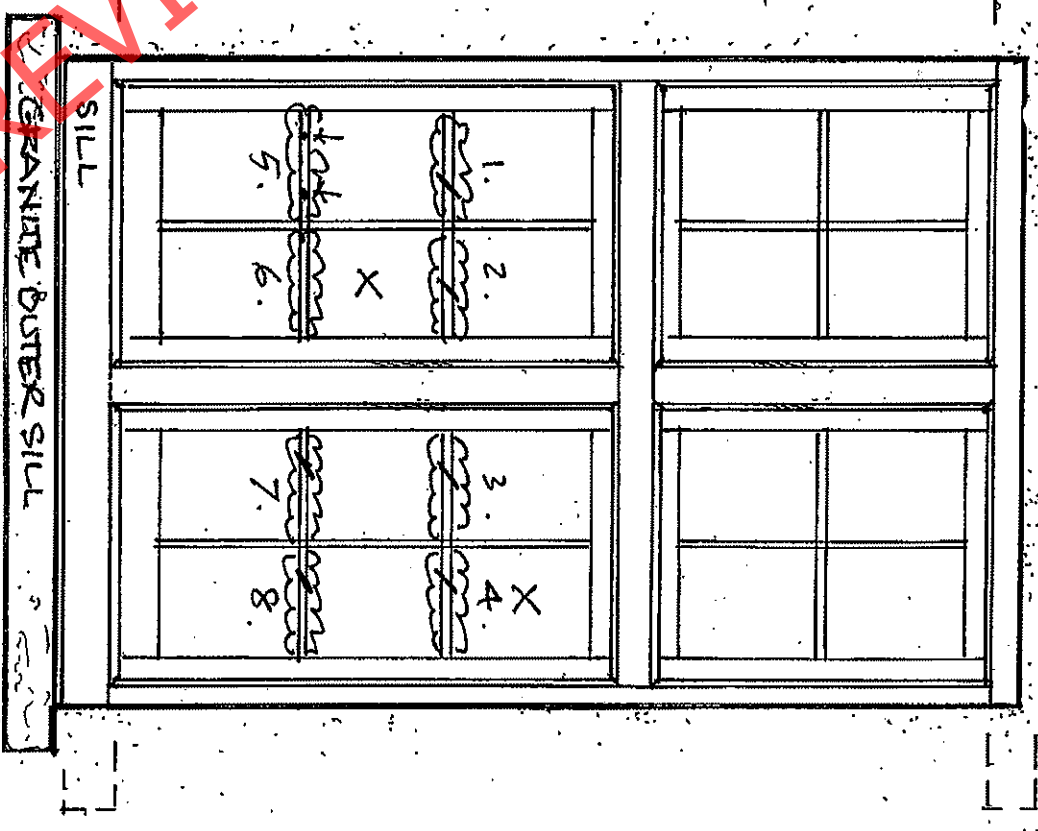
OUTSIDE
 8 NOSSES
 1:10 @ A3
 W1, W2, W3 - W6, W7, W8.
 26/5/13
 6/18
 W6

DISCURE
 NAIL ED
 POST
 DAMAGE
 TO REMOVE
 NAILS &
 GIVE UP
 PROPERLY

- inside:**
- W6 left (seen from inside) plane off to sound wood, plant on ± 20 mm thick x 47mm x ± 400 mm long teak.
- Close off damaged edge fully and reinstaate to suit hinge seating correctly.

- W6 centre post (seen from inside): carefully remove nails, lift splintered/cracked face, clean up and clear dust etc, offer and work in Balcotan 100 glue, paper cover and board and clamp flush to set flush and fine sand clean up after.

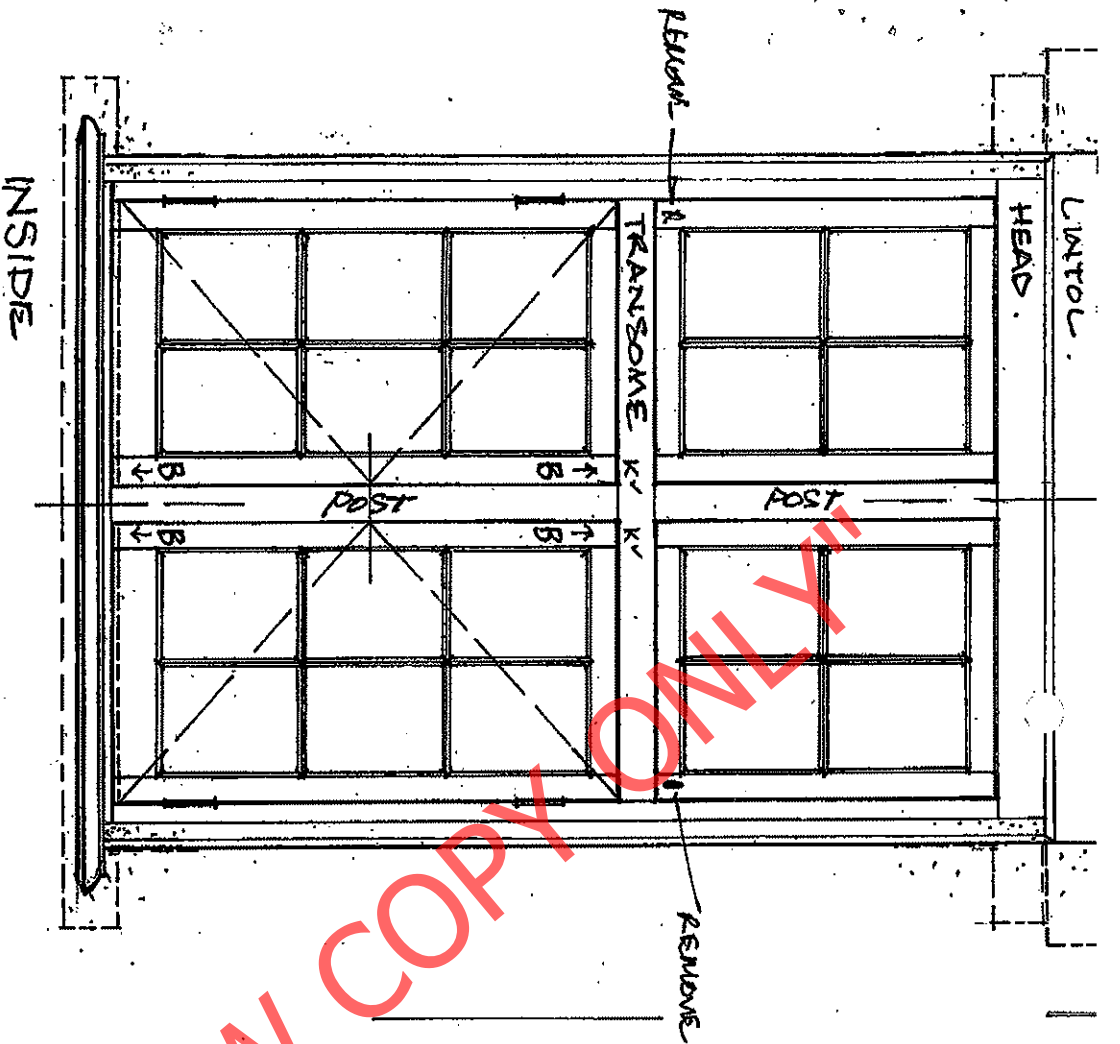
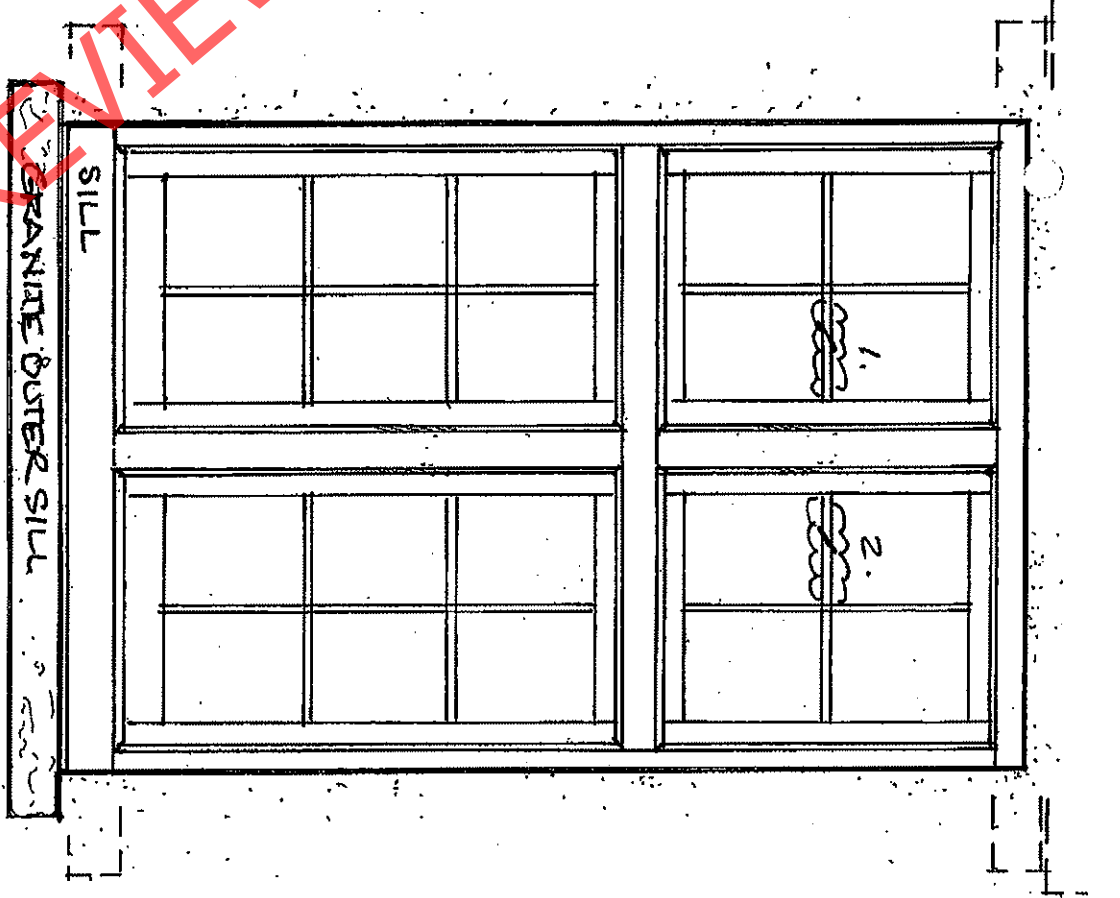
26/6/13
 8/8
 W8

1:10 @ A3
 W1, W2, W3 - W6, W7, W8.
 2 NOSSES.
