WINDOW REPORT

Agulhas lighthouse ground floor front windows
W1 to W8

John Rennie
 Rennie Scurr Adendorff Architects
 1301/WindowReport/Jr
 26 May 2013

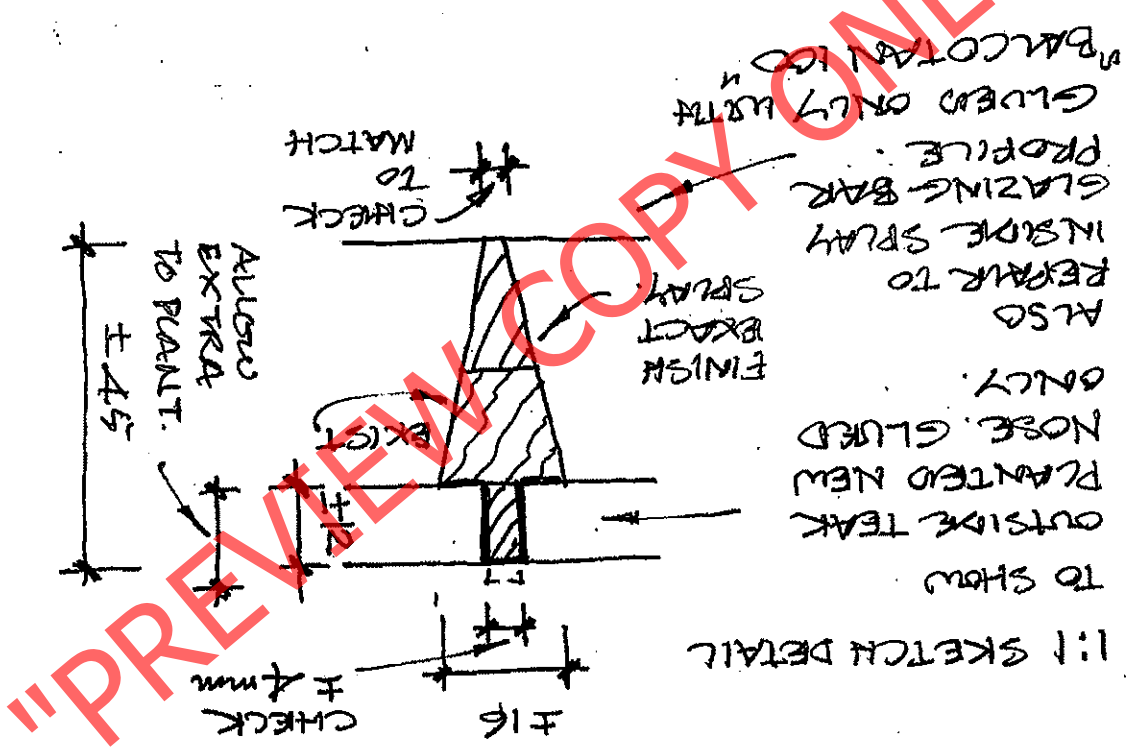
Read with 1:1 typical glazing bar sketch repair detail 26/5/13

AGENTS VERAMATH WINDOWS : -
 THE CARPENTERS ASSEMBLING THE
 NEW VERAMATH BALUSTRADE
 SUGGESTED AN ADDED APPROACH
 TO THE RE-NOSING OF THE SLENDER
 GLAZING BARS - WORTH TRYING OUT.
 IDEA TO ROUT OUT AN ACCURATE
 NOST GROOVE TO FACILITATE
 CENTERING & GUIDING THE NEW
 NOSSES : -

- The windows have vulnerable and delicately slender splay-moulded glazing bars (only $\pm 16\text{mm}$ thick).
- There are several bars with damage on the inside at the sharp splay noses, and many are worn thin but still intact otherwise. Outside, more seriously, several of the narrow slender noses between the glazing rebates have also been part broken, are missing or poorly replaced, now showing rusted pins, mismatched poor repair shape and thickness and added splitting damage. They need to be repaired as detailed to give the rule edge for puttywork. Bedding the panes in brown silicone (instead of back-patty) will hold the panes firmly permanently without pinning damage.
